RE: Review of Eighteenth (18th) Re-measure of Elevations at Monitoring Benchmarks and Monitoring Points Along the Water Line Segments W1A and W2A in the Woodlands, Texas

Review of Eighteenth (18th) Re-measure of the Elevations at Monitoring Points and Monitoring Benchmarks along Water Line Segments W1A and W2A

Overview of Eighteenth (18th) Re-measure of the Elevations at Monitoring Points and Monitoring Benchmarks along Water Line Segments W1A and W2A

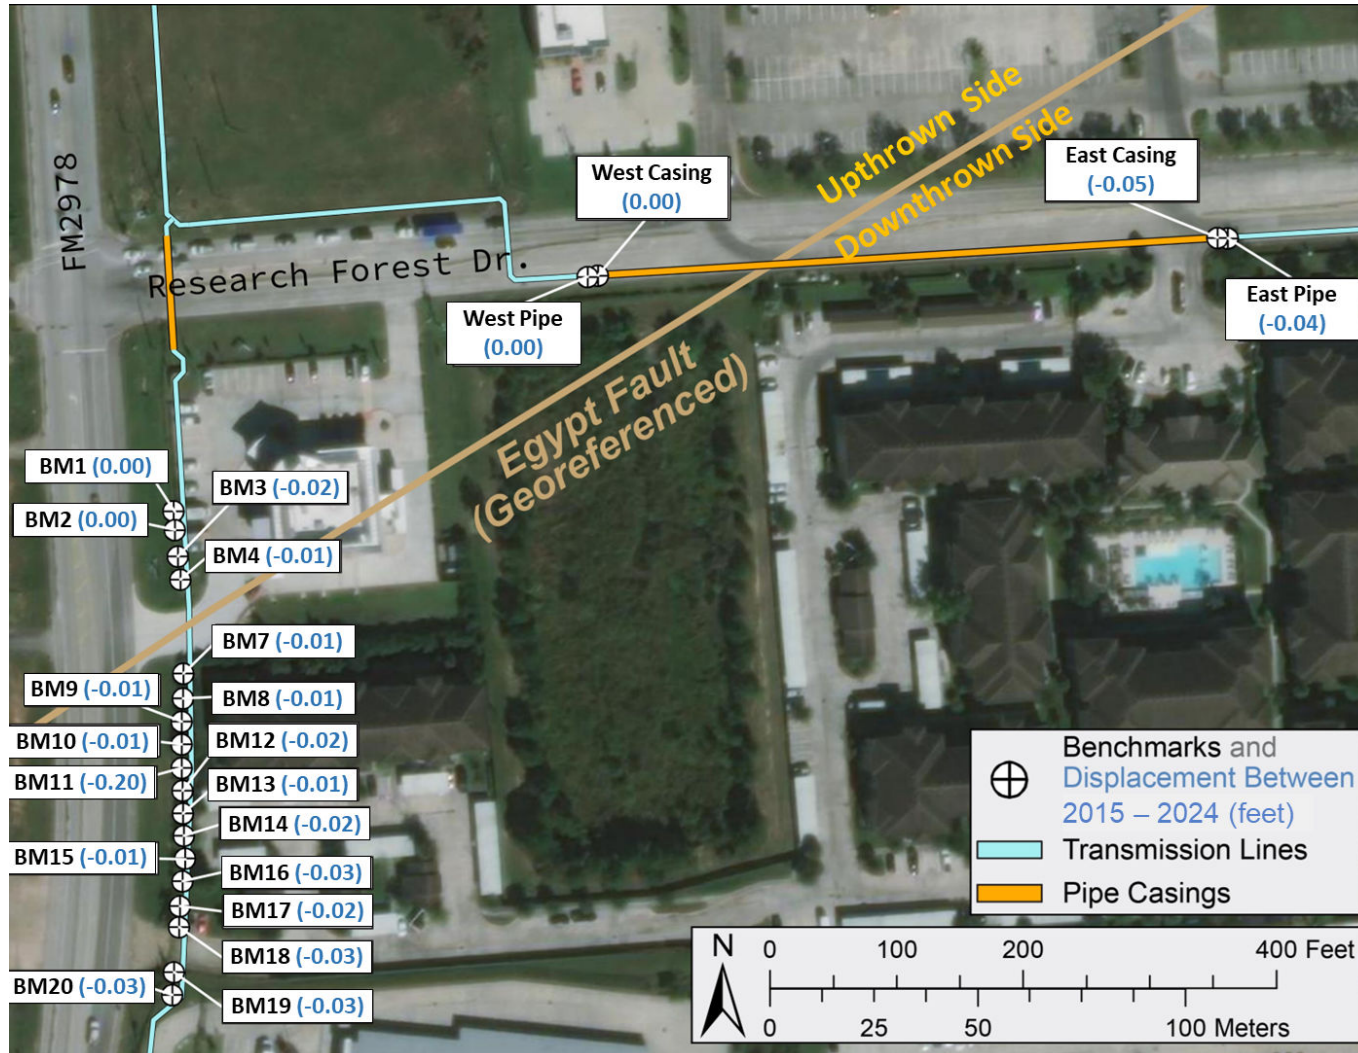
Egypt Fault Monitoring System - At the Egypt Fault Monitoring System (Figure 3), the changes in the elevations from March 2015 to March 2024 indicate that a greater decrease in pipe/casing elevation occurred on the downthrown side than on the upthrown side of the Egypt Fault. Over an 9-year period from 2015 to 2023, the pipe/casing elevation on the downthrown side of the Egypt Fault decreased 0.04 ft relative to the upthrown side of the Egypt Fault. The 0.04 ft decrease over an 8.5-year period translates into an average subsidence rate of approximately 0.0047 ft/yr.

W1A Segment - At the W1A segment where 18 monitoring benchmarks are located along FM 2978 (Figure 3), the changes in monitoring benchmark elevations from March 2015 to March 2024 indicate that a greater decrease in land elevation has occurred on the downthrown side than on the upthrown side of the Egypt Fault. Over the 8.5-year period from 2015 to 2023, the land surface on downthrown side of the Egypt Fault decreased 0.019 ft in elevation relative to the upthrown side of the Egypt Fault. The 0.019 ft decrease in land elevation over an 8.5-year period translates into an average subsidence rate of approximately 0.0022 ft/yr. (note: as explained below benchmark 11 was not included in the analysis).

During the last 9 years, the monitoring data indicates that more downward movement occurred on the downthrown side on the Egypt Fault. Along Research Forest Drive, the downthrown side of the fault averaged a decrease of 0.045 ft in elevation more than the upthrown side of the fault. This amount of elevation change indicates that the downthrown side of the Egypt Fault is subsiding at rate approximately 0.005 ft/yr relative to the upthrown side of the Egypt Fault. Along FM 2978, the downthrown side of the fault averaged a decrease 0.011 ft in elevation more than the upthrown side of the fault. These amounts of elevation change are too small to be consider conclusive evidence that land subsidence is occurring along Egypt Fault where it intersects FM 2978.

Figure 3 Satellite map showing the location of the Egypt Fault (Fugro, 2012), the W1A monitoring locations and calculated vertical displacement from March 2015 to March 2024 and the SJRA water line and pipe casing.

After 9 years of monitoring the change in the monitoring point elevations at the Egypt Fault Monitoring System, the downthrown side of the fault had subsided 0.045 ft relative to the upthrown side of the fault. Thus, the average rate of subsidence of the downthrown side of the fault relative to the upthrown side of the fault is approximately 0.005 ft/year. Based on the information that INTERA has reviewed, INTERA concludes the water line is not at risk of damage from land subsidence where it crosses the Egypt Fault along Research Forest Drive for the next 50 years if land subsidence continues at its current rate and if the SJRA safeguards work as designed.

Along FM 2978, the 16-inch water line extends to SJRA Woodlands Division Water Plant No. 4. Instead of using pipe casing to protect the water line, a SJRA contractor installed a series of ball connections in the vicinity of the Egypt Fault to accommodate movement of up to 0.25 inches of vertical movement per year over a 50-year period, or a total of 12.5 inches. Along a length of approximately 400 ft, six ball couplings were installed. During the 9 years of monitoring, the average changes in the monitoring benchmark elevations are a decrease of 0.008 ft and a decrease of 0.018 ft on the upthrown and downthrown side of the fault, respectively. Thus, the subsidence of the downthrown side of the fault relative to the upthrown side of the fault is approximately 0.011 over 9 years, which translates to 0.0012 ft/yr. Based on the information that INTERA has reviewed, INTERA concludes that the water line is not at risk of damage from land subsidence where it crosses the Egypt Fault along FM 2978 for the next 50 years if land subsidence continues at its current rate and if the SJRA safeguards work as designed.

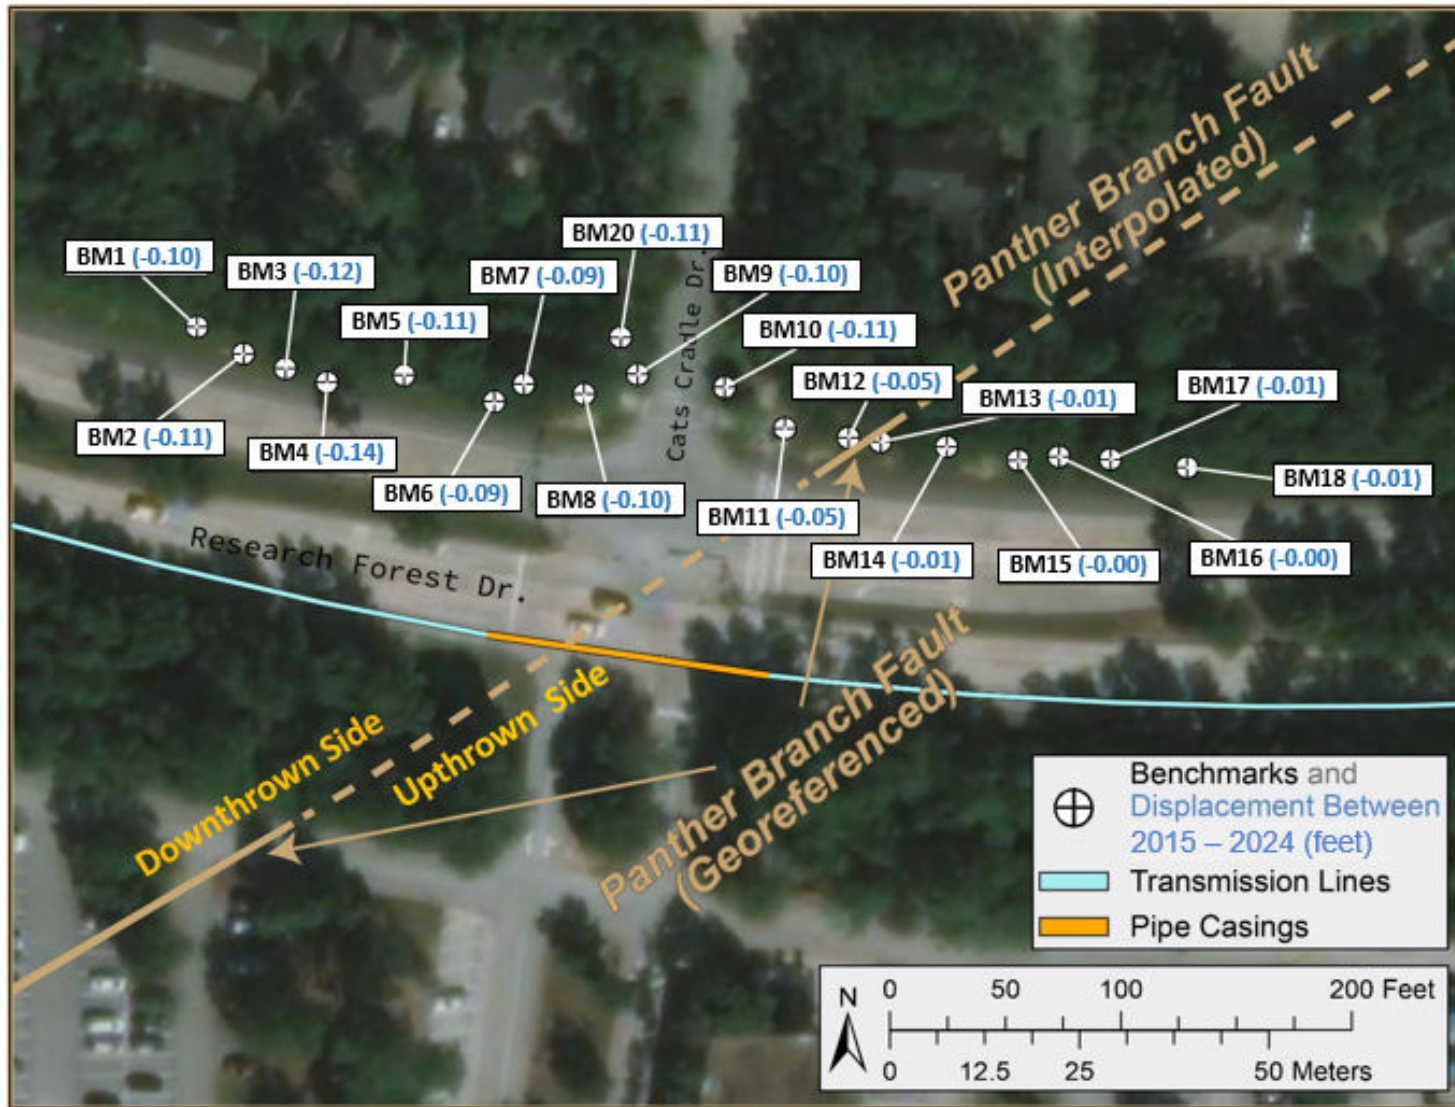
W2A Segment - Along the W2A segment where 19 monitoring benchmarks on Research Forest Drive are located near the suspected Panther Branch Fault (Figure 5), the changes in the monitoring benchmark elevations suggest that greater land subsidence has occurred on the downthrown side than on the upthrown side of the suspected Panther Branch Fault. Based on the change in elevations of the 19 monitoring benchmarks over an 8.5-year period from March 2015 to March 2024, the land surface on downthrown side of the suspected Panther Branch Fault decreased 0.084 ft in elevation relative to the upthrown side of the suspected Panther Branch Fault. The 0.084 ft decrease in land elevation over an 9 year period translates into an average subsidence rate of approximately 0.0099 feet per year (ft /yr).

The changes in the elevation at the monitoring benchmarks near the suspected Panther Branch Fault indicate that the downthrown side of the fault has subsided approximately 0.092 ft more than the upthrown side of the fault. The 0.092 ft decrease in elevation over 9 years translates into an average subsidence rate of approximately 0.01 ft/yr since March 2015.

Figure 5 Satellite map showing the location of the suspected Panther Branch Fault mapped by INTERA, the Segment W2A Monitoring System, calculated vertical displacement from March 2015 to March 2024, and the SJRA water line and pipe casing.

Because the Fugro report (2012) did not show that the suspected Panther Branch Fault crossing the water line, SJRA’s consultant did not design nor did SJRA’s contractor construct safeguards to protect the water line from differential subsidence associated with the suspected Panther Branch Fault. The average change in the monitoring benchmark elevations at the suspected Panther Branch Fault over 9 years for the upthrown side and for the downthrown side of the Big Barn Fault are a decrease of 0.007 ft in elevation and a decrease of 0.098 ft in elevation, respectively. Thus, the decrease of the downthrown side of the fault relative to the upthrown side is about 0.092 ft over 9 years, or approximately 0.0102 ft/yr. Figure 7 shows that since March 2022, the rate is 0.028 ft/yr. Per discussion with SJRA, SJRA plans to continue to monitor subsidence using the benchmarks associated with the Segment W2A Monitoring System and to investigate what safeguards may be needed to protect the transmission line.

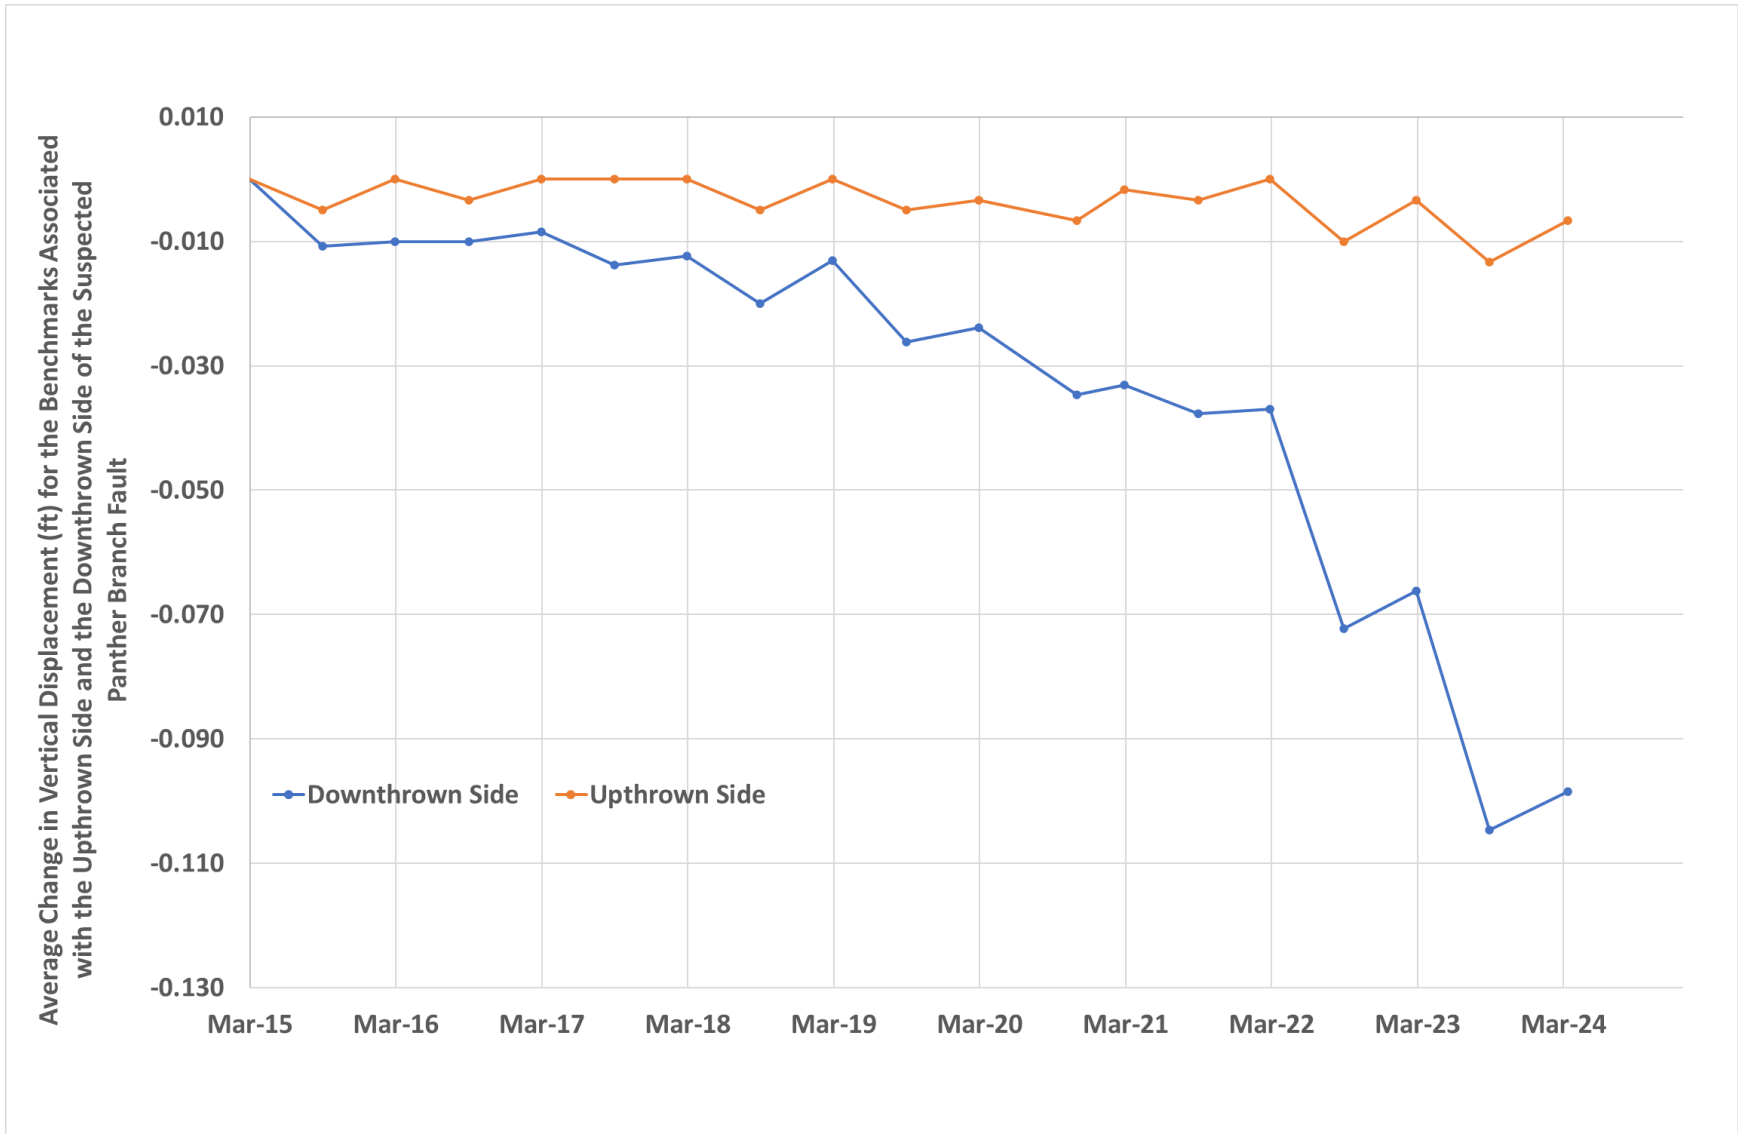
Figure 6 shows graphs for the average vertical displacement calculated for the benchmarks located on the upthrown side and the downthrown side of the suspected Panther Branch Fault as a function of time since March 2015. The graphs show that the downthrown side of the fault has consistently greater decrease in elevation than does the upthrown side. Whereas the upthrown side of the fault has not subsided more than 0.015 ft over a 6-month period within the 9-year monitoring period, the downthrown side of the fault has exhibited a general trend of declining elevation with greater displacement rates at later times. Over the 9-year monitoring period, the downthrown side of the Panther Branch Fault a maximum decline of about 0.14 ft over a 6-month periods

Figure 6 Comparison of average vertical displacement for the benchmarks located on the upthrown side and the downthrown side of the suspected Panther Branch Fault associated with the Segment W2A Monitoring System.

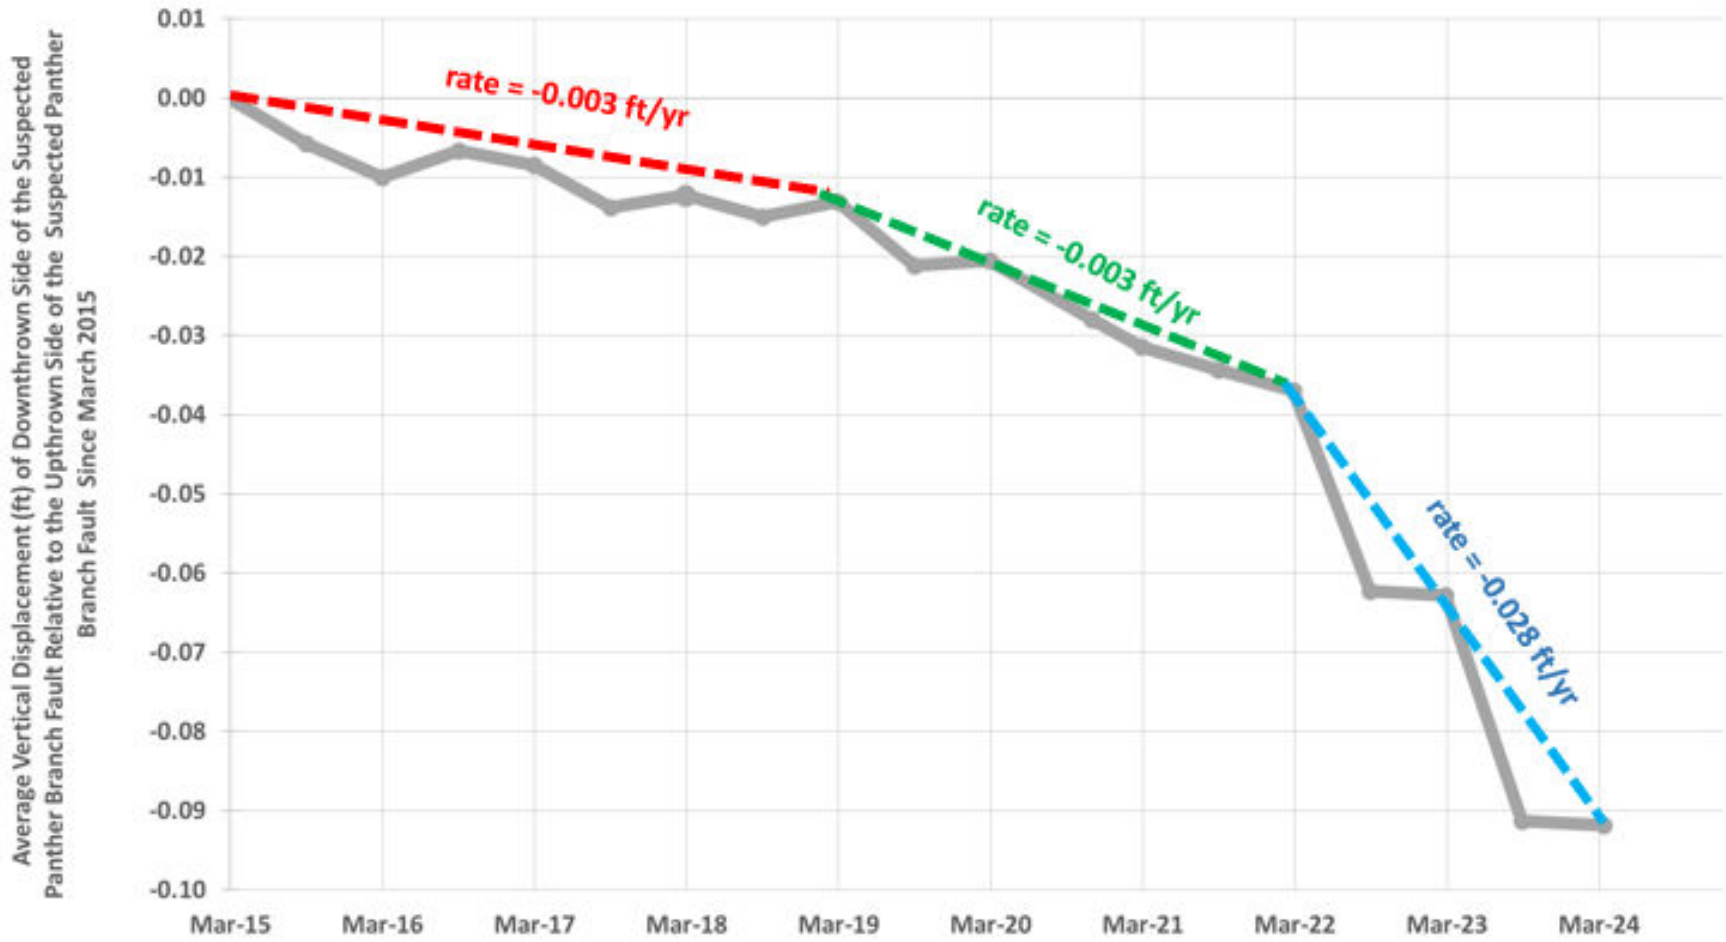
Figure 7 and **Table 5** show the rates of vertical displacement for the downthrown side of suspected Panther Branch Fault relative to the upthrown side of the suspected Panther Branch Fault. The relative rate is calculated by subtracting the rate of displacement of the upthrown side from the rate of displacement of the downthrown side. The temporal changes in the displacement has been divided into three periods: 1) from March 2015 to March 2019, the rate of vertical displacement averaged 0.003 ft/yr downward; 2) from March 2019 to March 2022, the vertical displacement rate averaged 0.008 ft/yr downward; and 3) from March 2022 to March 2024, the vertical displacement rate averaged 0.028 ft/yr downward.

Relative vertical displacement and rates for relative vertical displacement for the downthrown side of the suspected Panther Branch Fault based on benchmarks associated with the Segment W2A Monitoring System

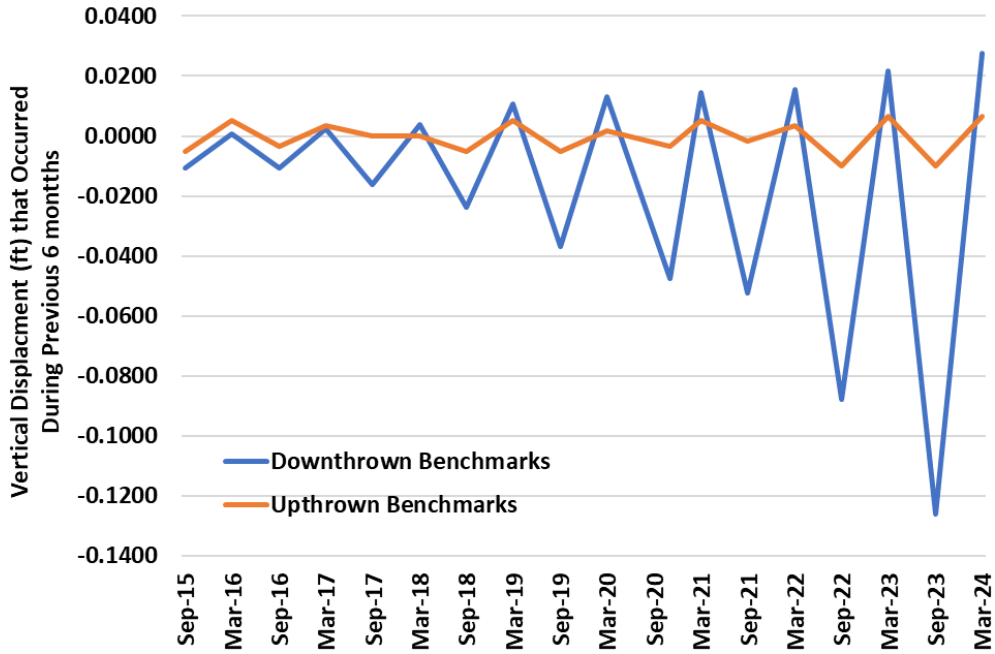
Figures 6 and 7 show a cyclic pattern in the vertical displacement that is characterized by greater subsidence occurring during the summer months than winter months. **Figure 8** and Table 6 show the vertical displacements that have occurred during the 6-month intervals preceding the March and September measured benchmark elevations. From March to September subsidence occurs on both sides of the fault whereas from September to March rebound occurs on both sides of the fault. For both six-month intervals, the vertical offsets are much greater for the downthrown benchmarks than for the upthrown benchmarks. For both set of benchmarks, the magnitude of the vertical displacements have steadily increased over time with the greatest rate of increases having occurred during the last two years.

- before 2020 wet soil conditions occurred for both summer and winter months which is consistent with the smaller amounts of vertical displacements from 2015 to 2019 in Figure 8;
- after 2020 the soils became gradually drier which is consistent with increasingly greater vertical displacements in Figure 8;
- during summer months from 2021 to 2023 where moderate drought conditions existed, the largest amounts of subsidence occurred.

Figure 8 Vertical displacement that occurred during the 6-month intervals preceding the March and September measurements of elevations at the benchmarks associated with the Segment W2A Monitoring System along the suspected Panther Branch Fault.

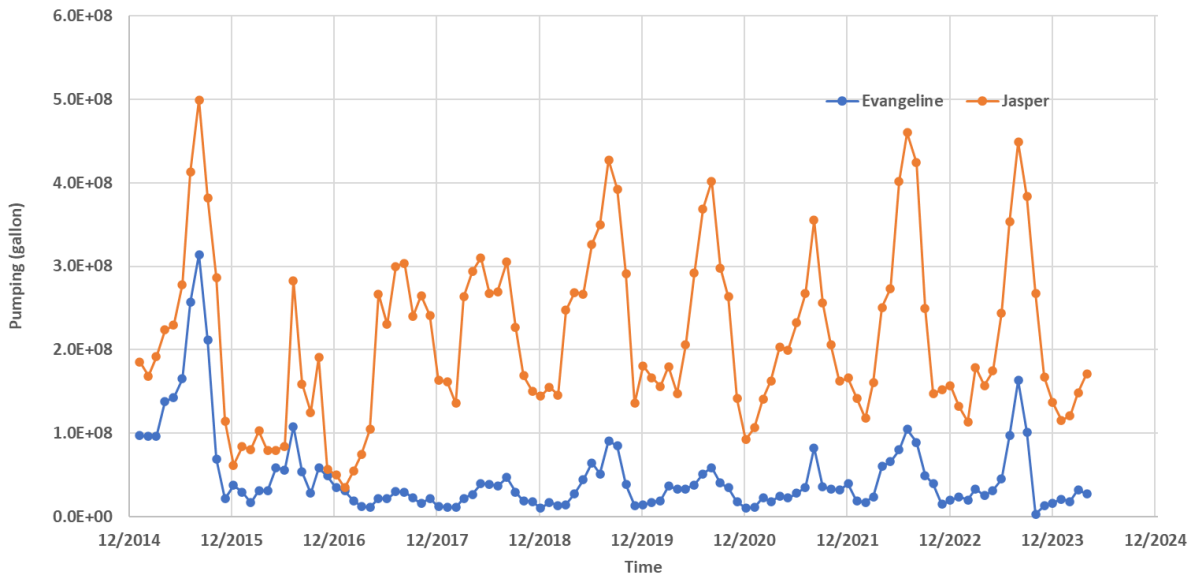
Among the potentially important feature of Figure 11 is the large increases in the production from the Evangeline aquifers in 2022 and 2023. If this production increase caused a reduction in the water pressure, then the higher pumping rates would have contributed to the increase in the subsidence rates during the summer months in 2021, 2022, and 2023.

Figure 11 Monthly production from the Woodlands Wells from the Evangeline and Jasper aquifers.
