RE: Review of Eighteenth (18th) Re-measure of Elevations at Monitoring Benchmarks and Monitoring Points Along the Water Line Segments W1A and W2A in the Woodlands, Texas

Review of Eighteenth (18th) Re-measure of the Elevations at Monitoring Points and Monitoring Benchmarks along Water Line Segments W1A and W2A

Overview of Eighteenth (18th) Re-measure of the Elevations at Monitoring Points and Monitoring Benchmarks along Water Line Segments W1A and W2A

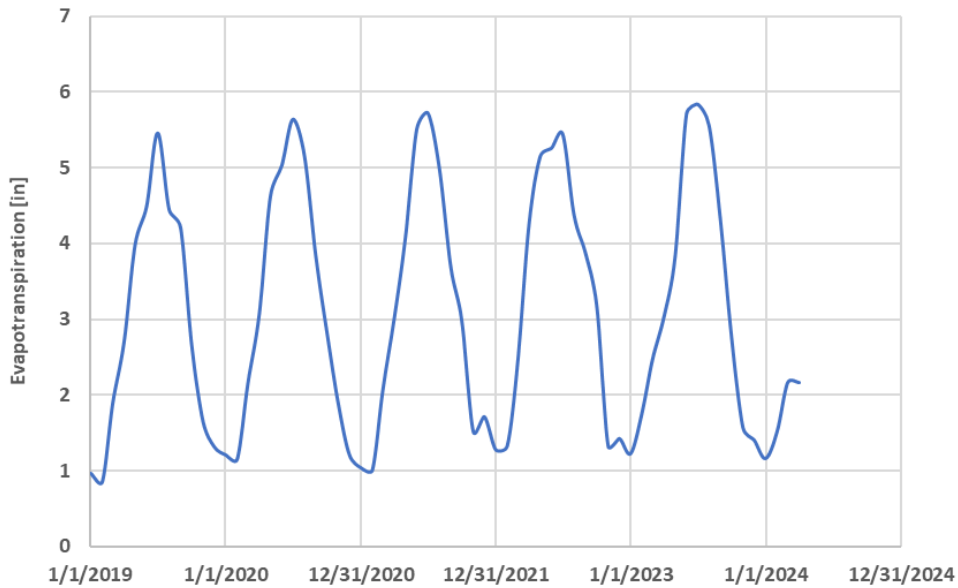
Figure 9 Monthly evapotranspiration (ET) amounts obtained for Segment W2A Monitoring System along the suspected Panther Branch Fault by OpenET (<https://etdata.org/faq>) Average cumulative ET amount from March to September and from September to March is 27.3 inches and 10.7 inches, respectively.

A primary factor that contributes to seasonal patterns of drying and wetting of soils is evapotranspiration (ET). **Figure 9** shows monthly values for evapotranspiration at the Segment W2A Monitoring System obtained from the OpenET data portal (<https://etdata.org>). The OpenET values presented here is an ensemble average of 6 different algorithms based on thermal satellite data and auxiliary data (Melton and others, 2022). The monthly values show a distinctive cyclic pattern with approximately 270% greater ET from March to September than from September to March. Besides ET, the monthly Palmer Drought Severity Index (PDSI) values in **Figure 10** are consistent with the cyclic pattern in the vertical displacement and the greatest subsidence rates during the summer of 2022 and 2023. PDSI data for Montgomery County was obtained from the Western Regional Climate Center (2024).

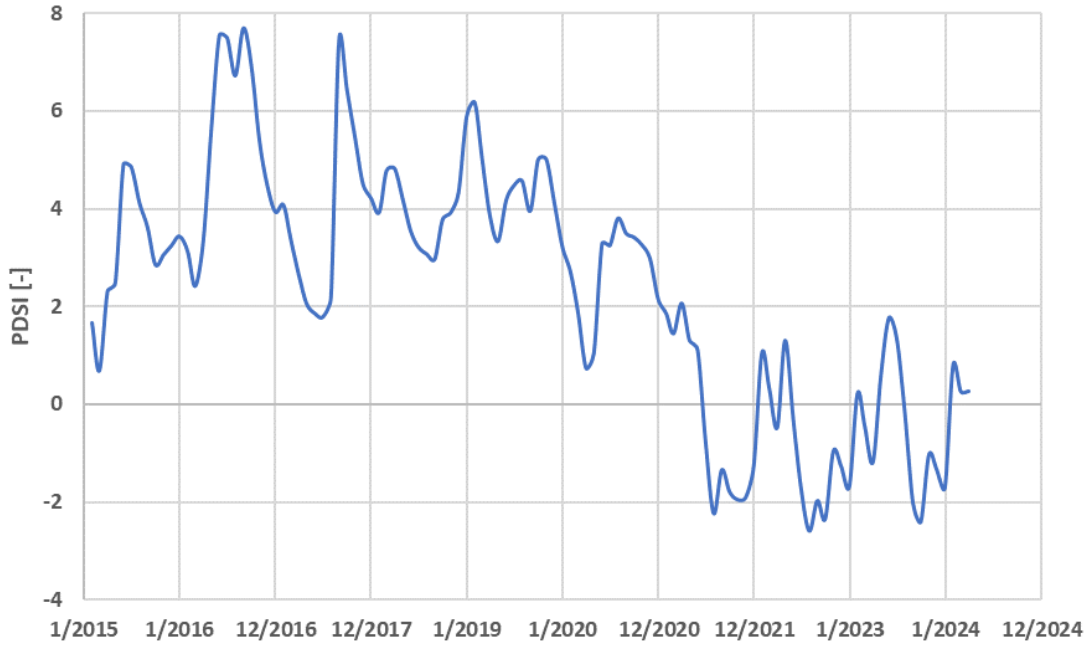
Figure 10 Monthly values for the Palmer Drought Severity Index (PSDI) form estimating relative dryness of soils for Montgomery County (from <https://wrcc.dri.edu/wwdt/time/>.)

The PDSI is used to estimate the relative dryness of the soil and is calculated from ET, rainfall, the soil water holding capacity from soil map developed by the National Cooperative Soil Survey. PSDI values range from +10 to -10 with lower number represent drier conditions. Table 7 provides additional details on the soil's classifications associated with the PSDI numbers. Among the saline features in Figure 10 are:

- before 2020 wet soil conditions occurred for both summer and winter months which is consistent with the smaller amounts of vertical displacements from 2015 to 2019 in Figure 8;
- after 2020 the soils became gradually drier which is consistent with increasingly greater vertical displacements in Figure 8;
- during summer months from 2021 to 2023 where moderate drought conditions existed, the largest amounts of subsidence occurred.
